First Five-Year CERCLA Review of Seven Pearl Harbor Naval Complex National Priorities List Sites

JOINT BASE PEARL HARBOR-HICKAM, OAHU, HAWAII

September 2014

**Department of the Navy
Naval Facilities Engineering Command, Hawaii
400 Marshall Road
JBPHH HI 96860-3139**

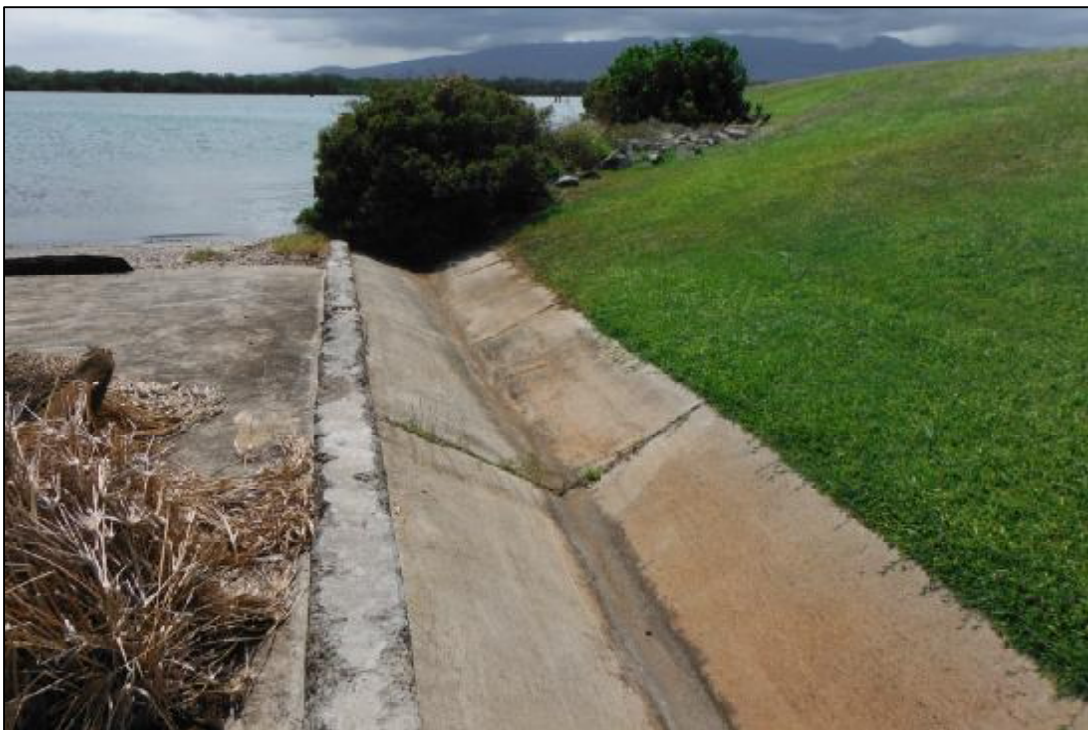
Photograph No. 2: Vegetation growing in swale outlet at south end of site.

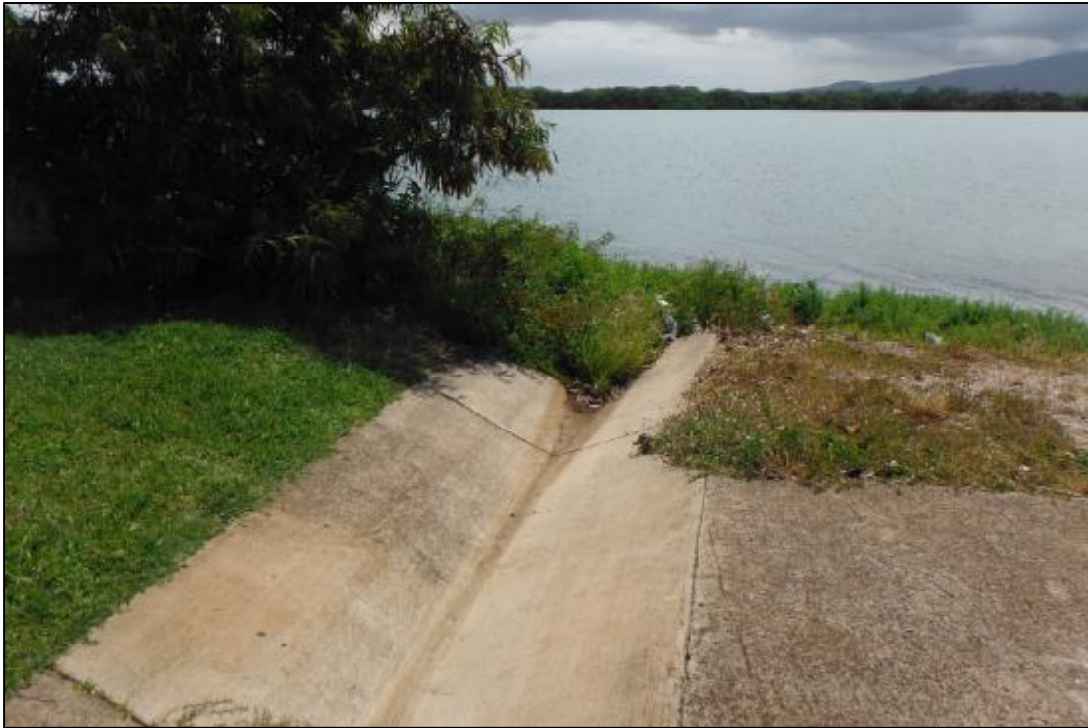
Photograph No. 3: Grass growing in swale outlet at north end of site.

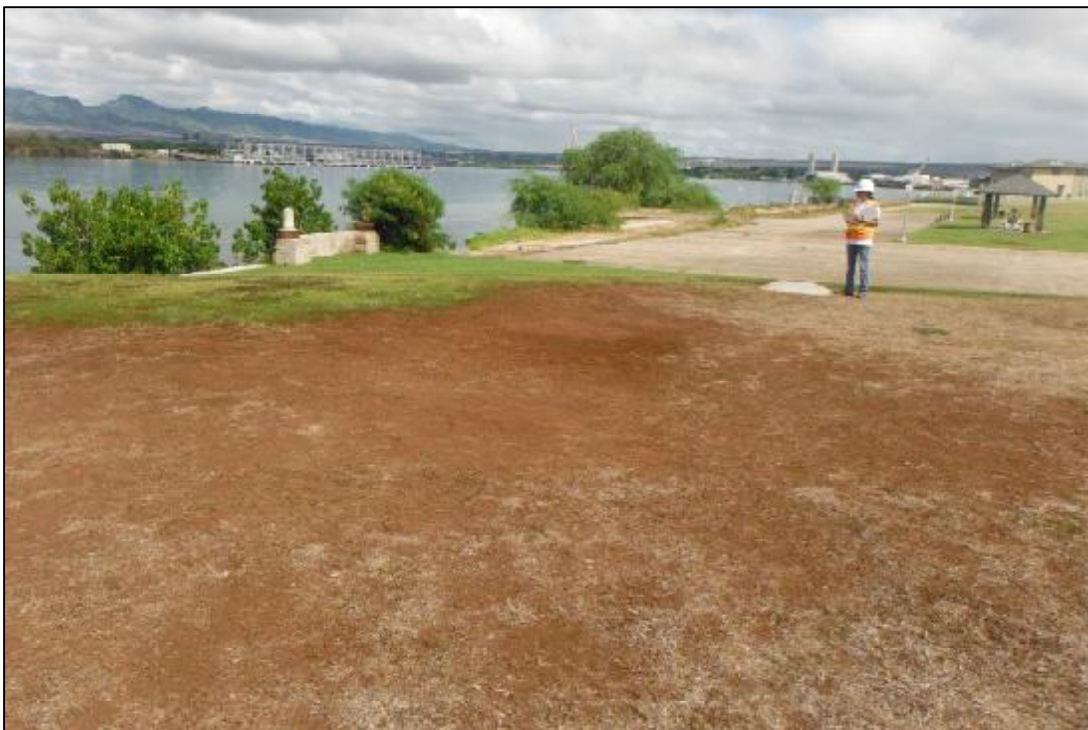
Photograph No. 4: Exposed soil in northwest area of site, looking northwest.

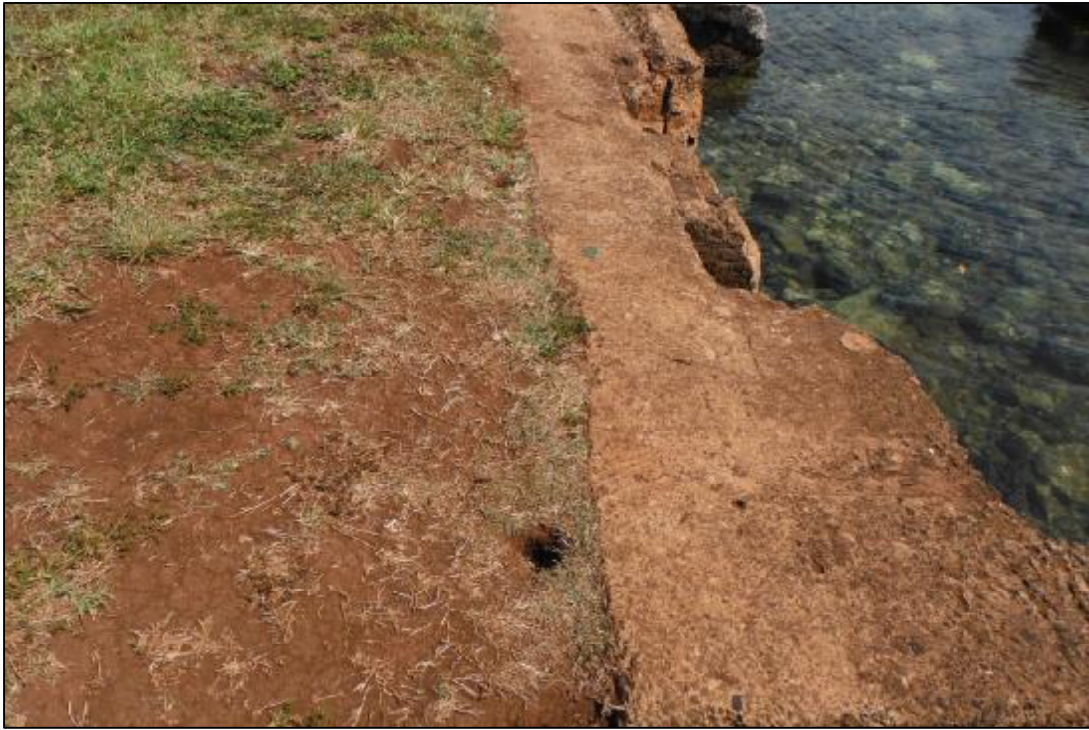
Photograph No. 5: Exposed soil near to shoreline in northwest part of site.

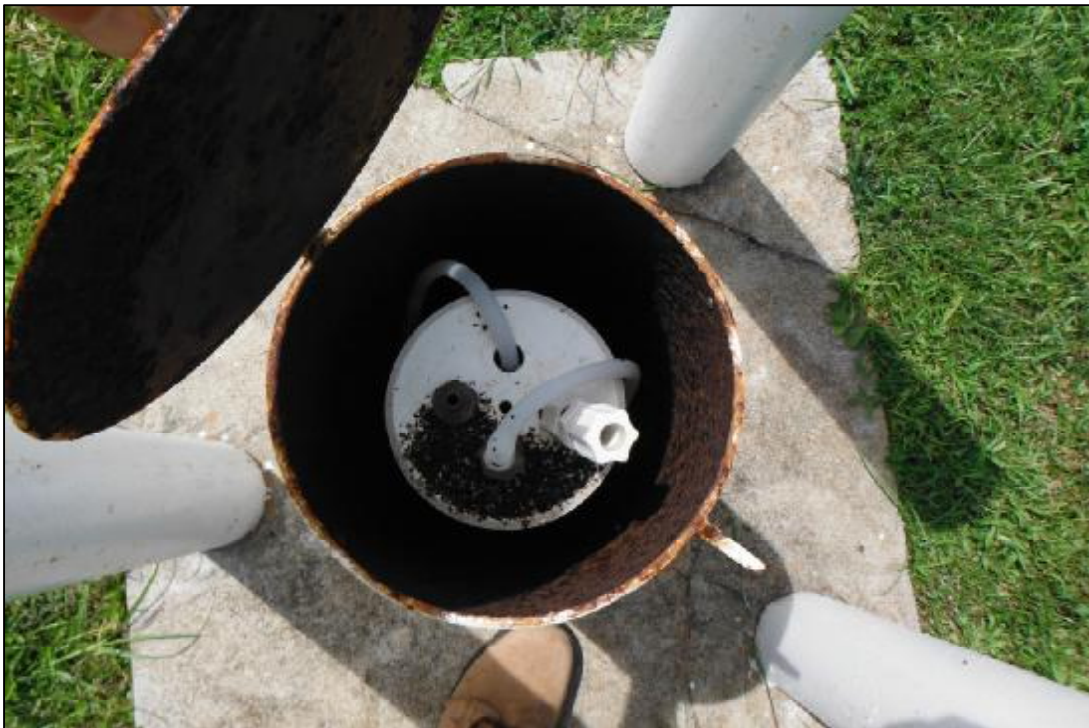
Photograph No. 6: Unlocked monitoring well observed on site.

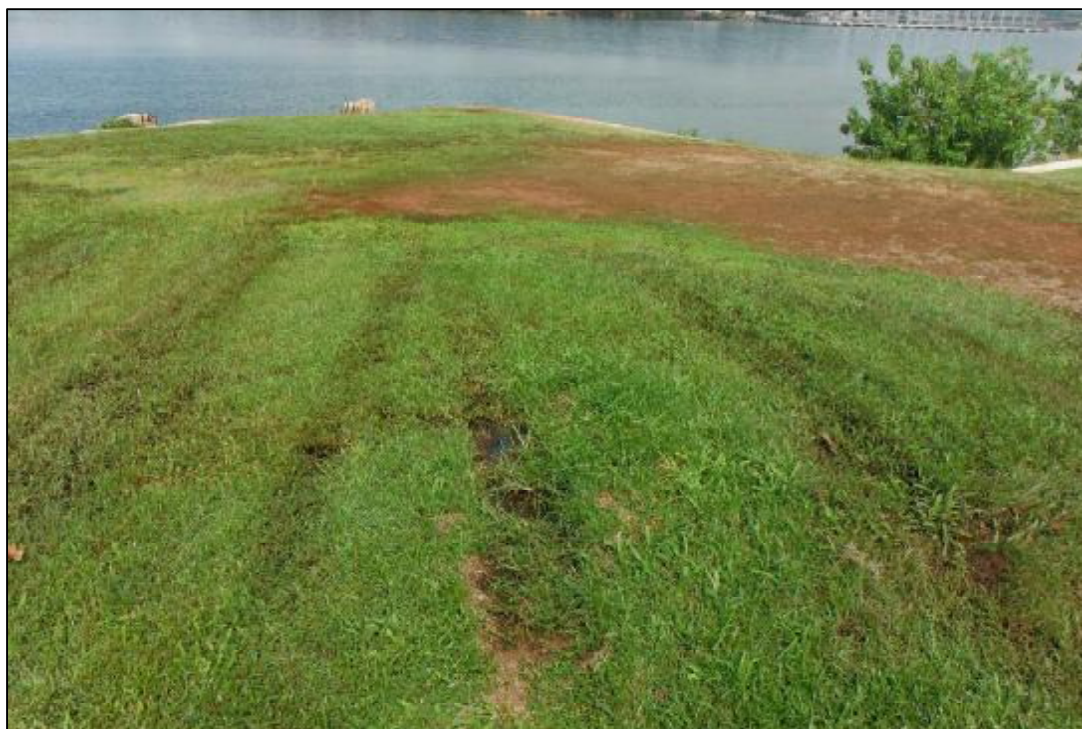
Photograph No. 8: Vehicle marks in grass on northwest part of site.

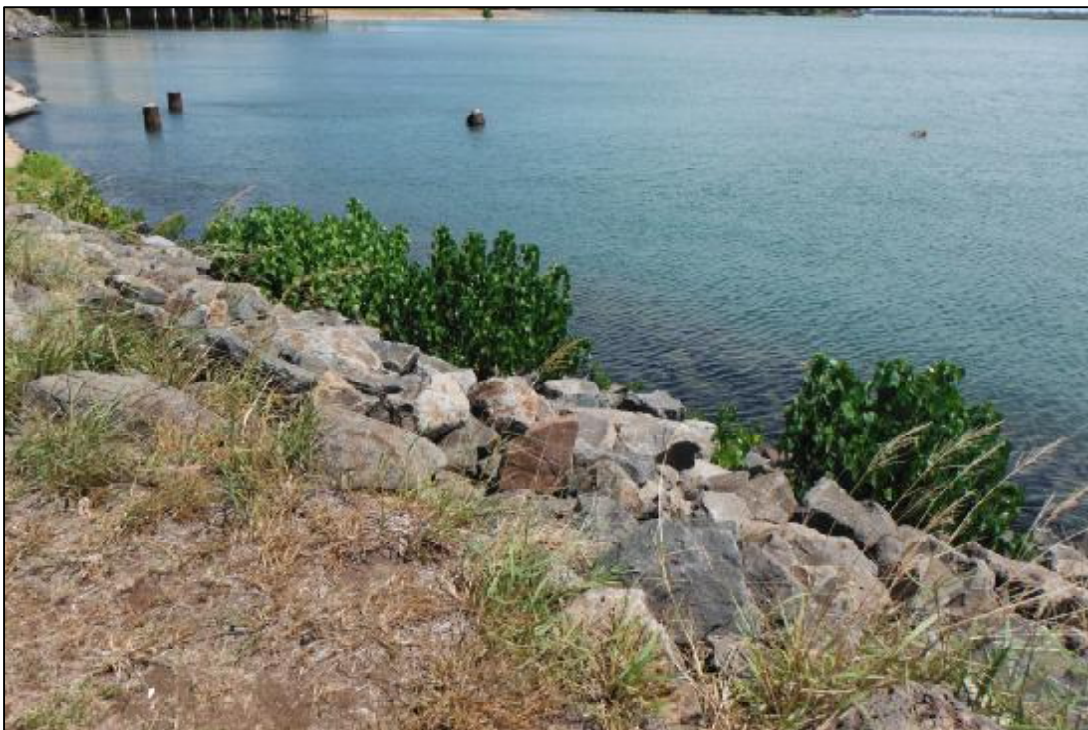
Photograph No. 2: Vegetation growing in rip-rap bordering shoreline at Bldg. 284 site.

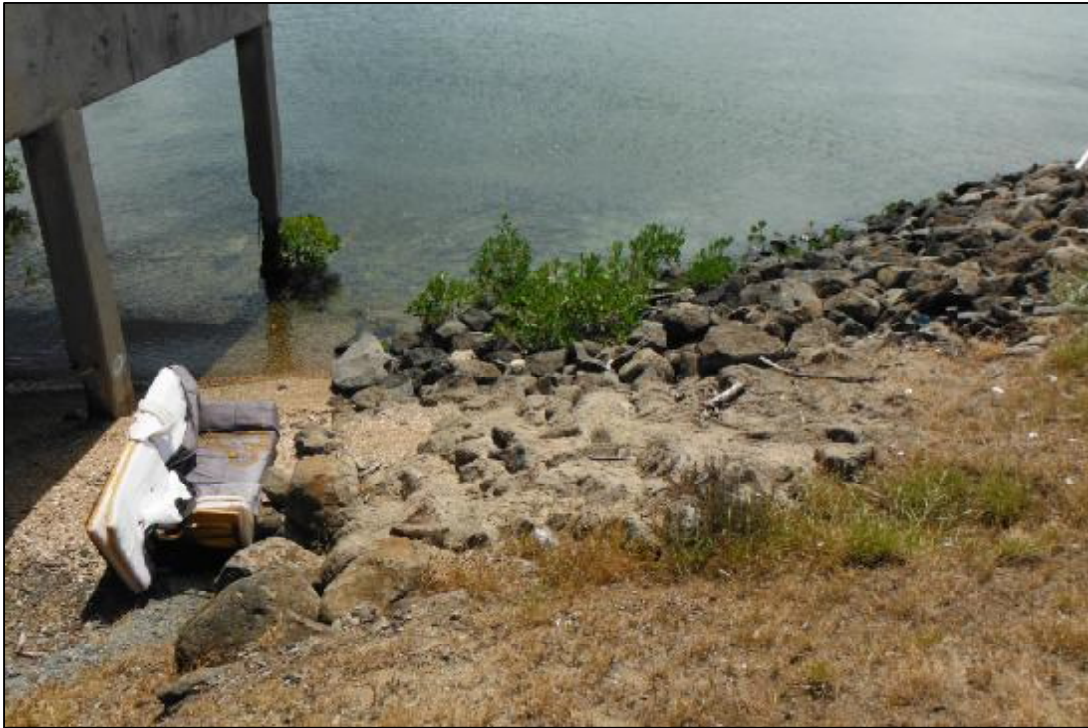
Photograph No. 3: Abandoned furniture on south end of Bldg. 284 site.

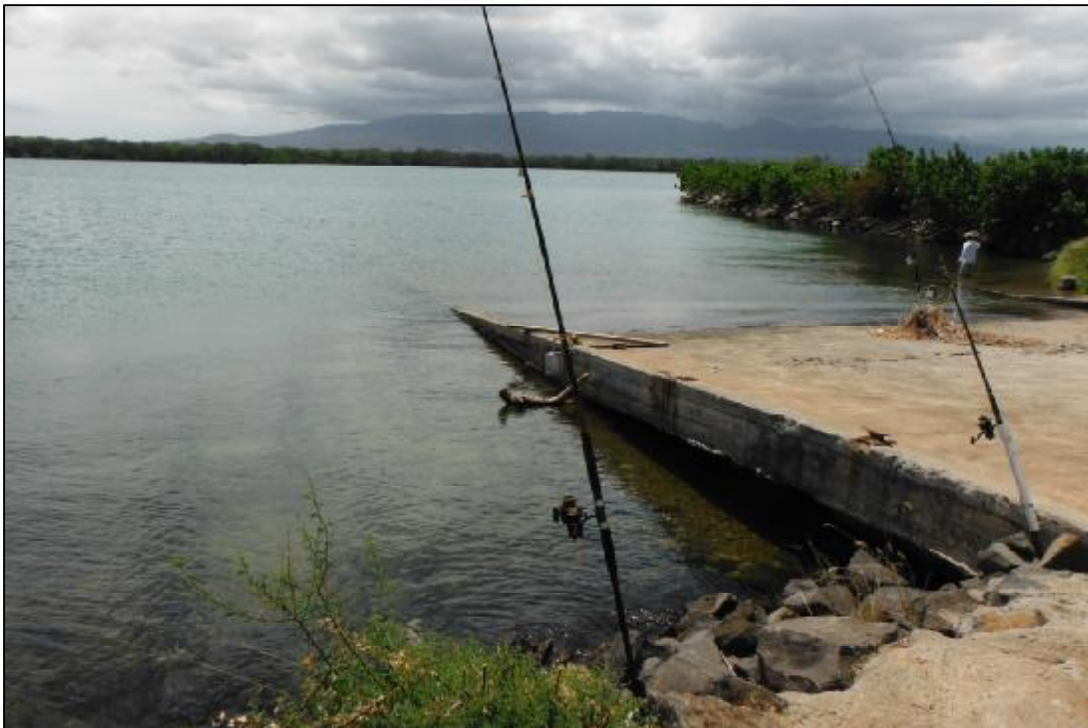
Photograph No. 4: Unauthorized fishing occurring immediately north of Bldg. 284 LUC area.

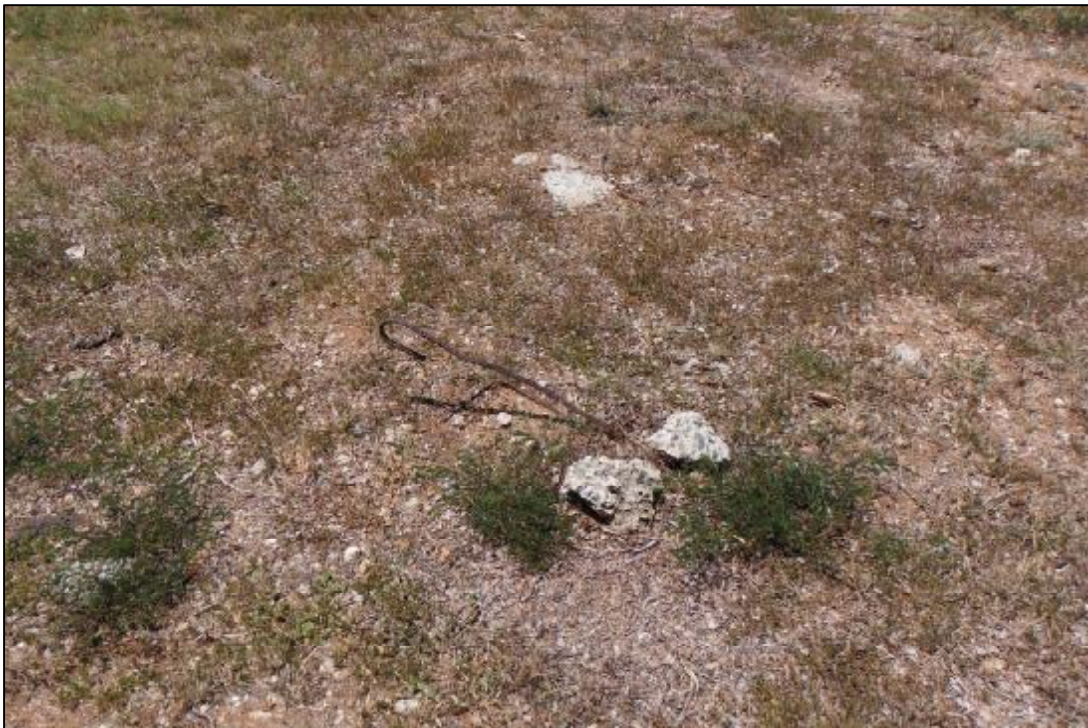
Photograph No. 8: Exposed metal and concrete debris around soil cap at former Bldgs. 80/302.

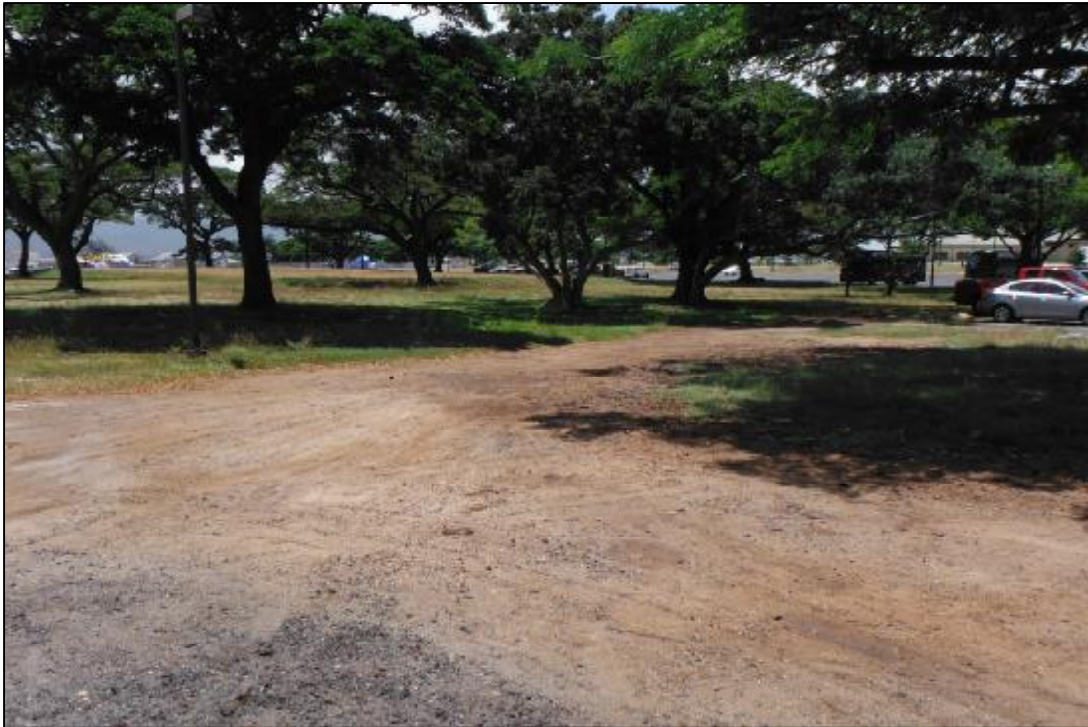
Photograph No. 9: Unpaved road and bare soil within LUC area to east of soil cap at former Bldgs. 80/302.

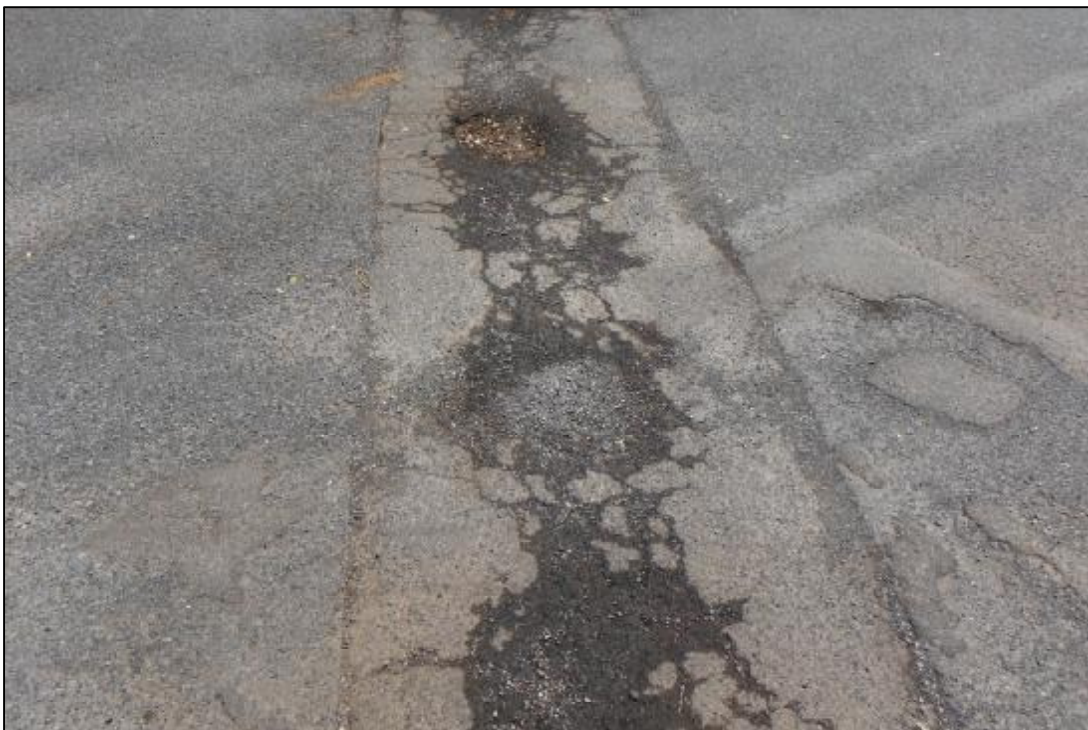
Photograph No. 10: Cracks in paved parking lot north of soil cap at former Bldgs. 80/302.

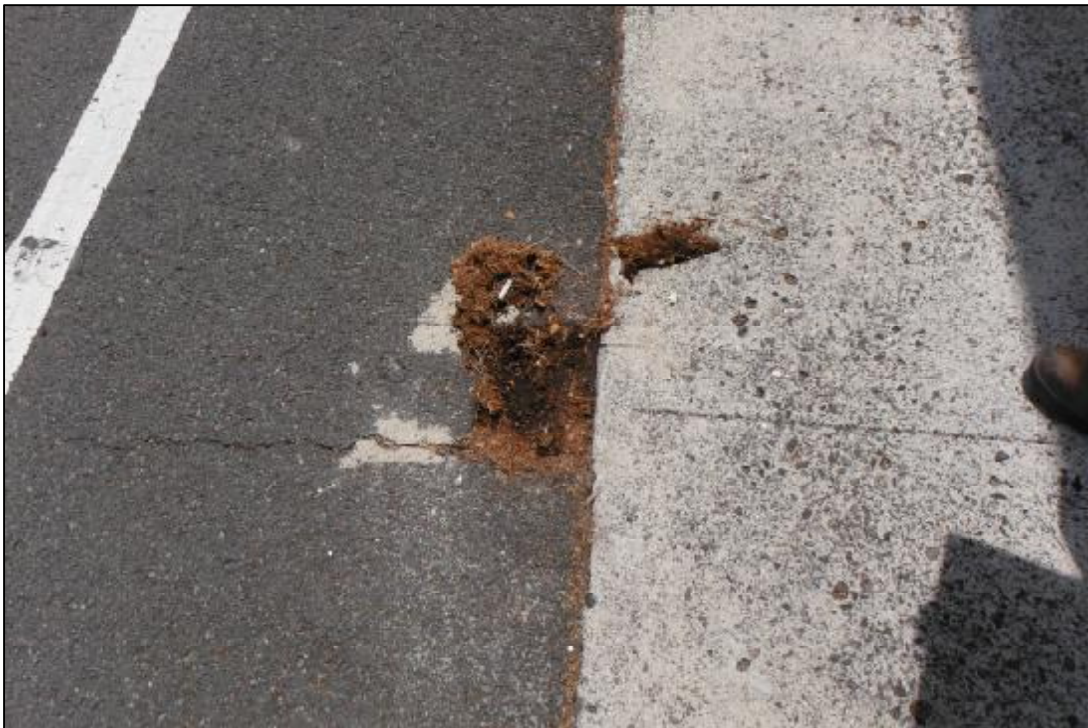
Photograph No. 12: Hole in asphalt pavement to south of Bldg. 3.

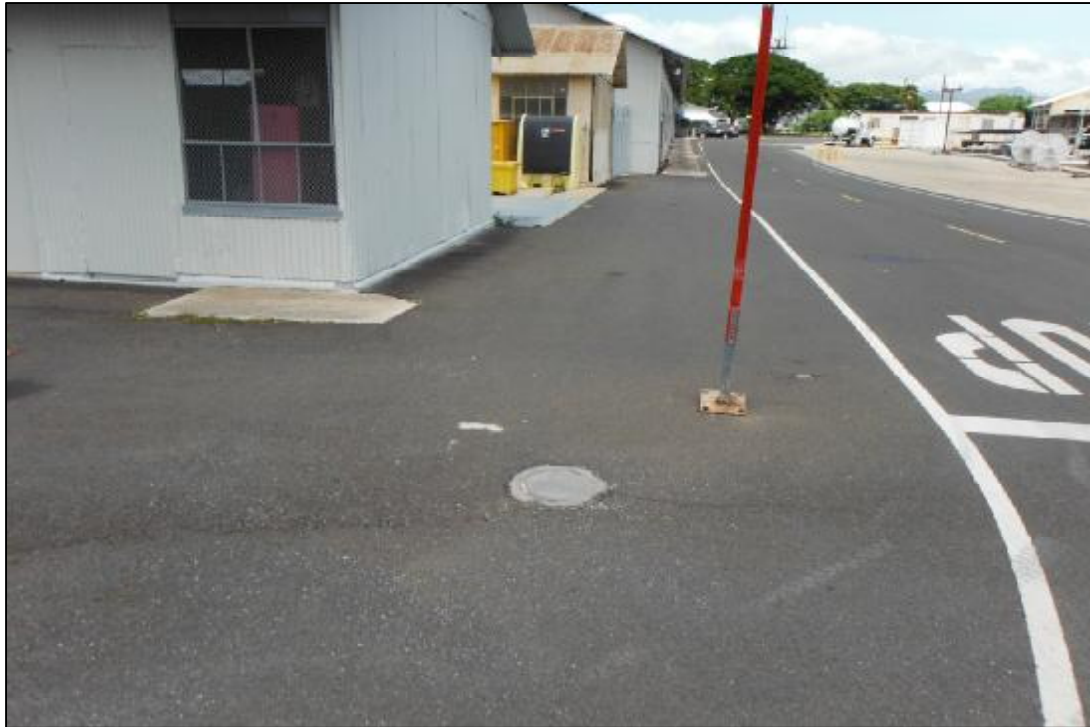
Photograph No. 13: View of area to south of Bldg. 3, looking east. Abandoned monitoring well in foreground.

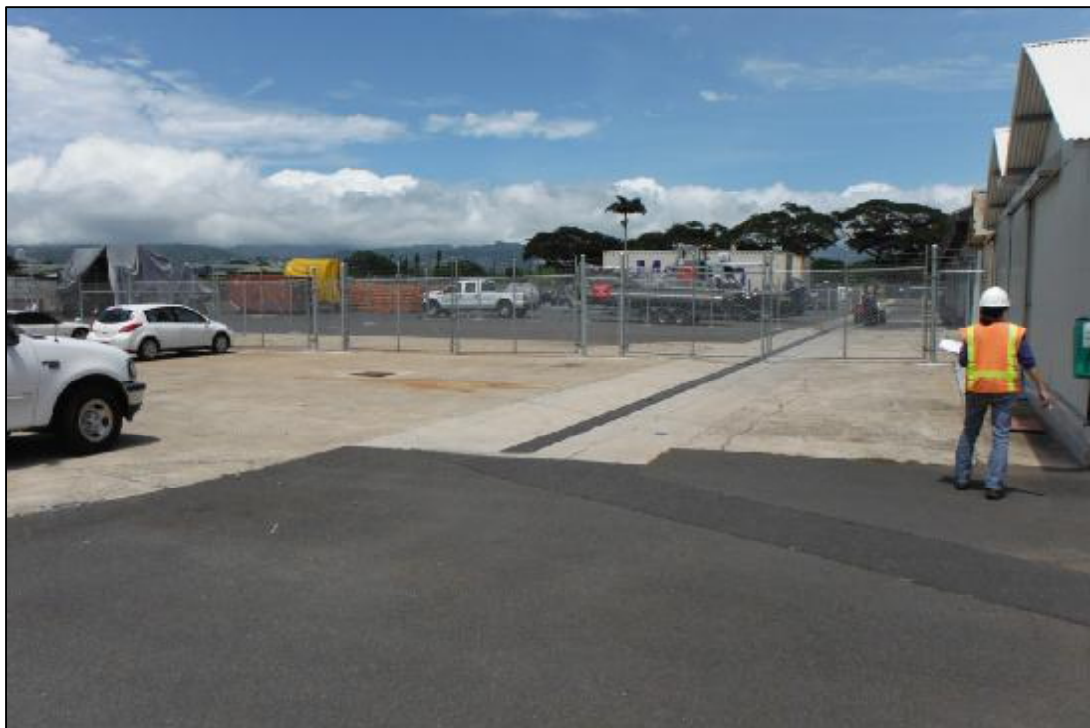
Photograph No. 14: Fenced area storage yard north of Bldg. 3. Area previously identified as being covered with coral gravel was observed with asphalt paving.

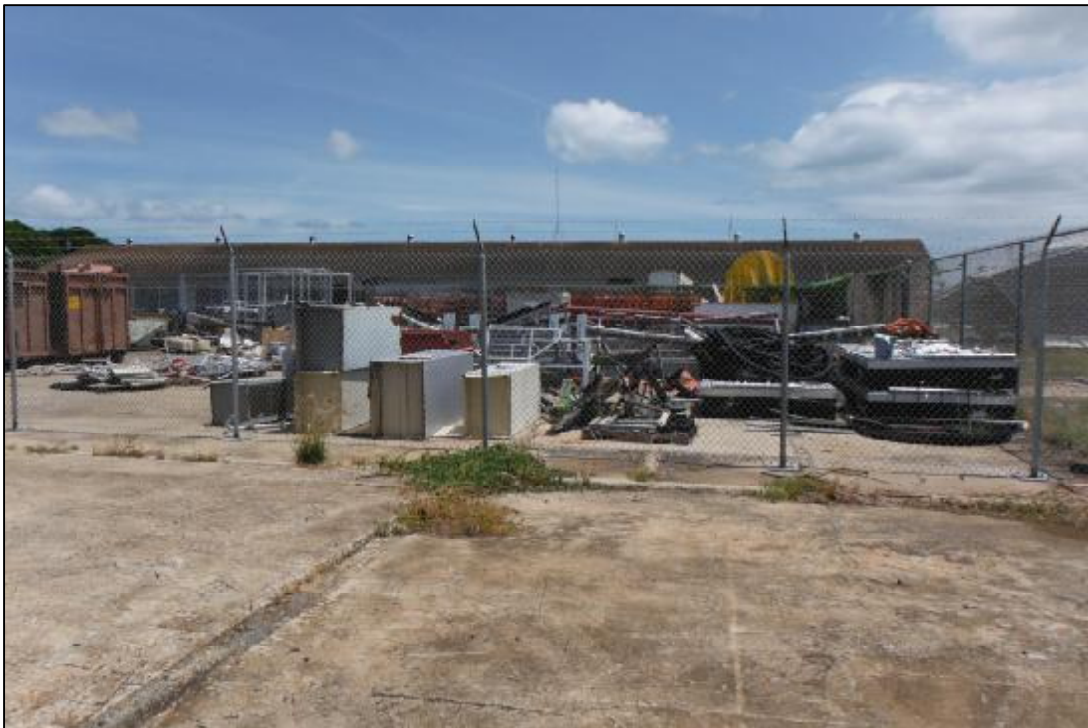
Photograph No. 16: Various supplies stored within the LUC area north of Bldg. 3.

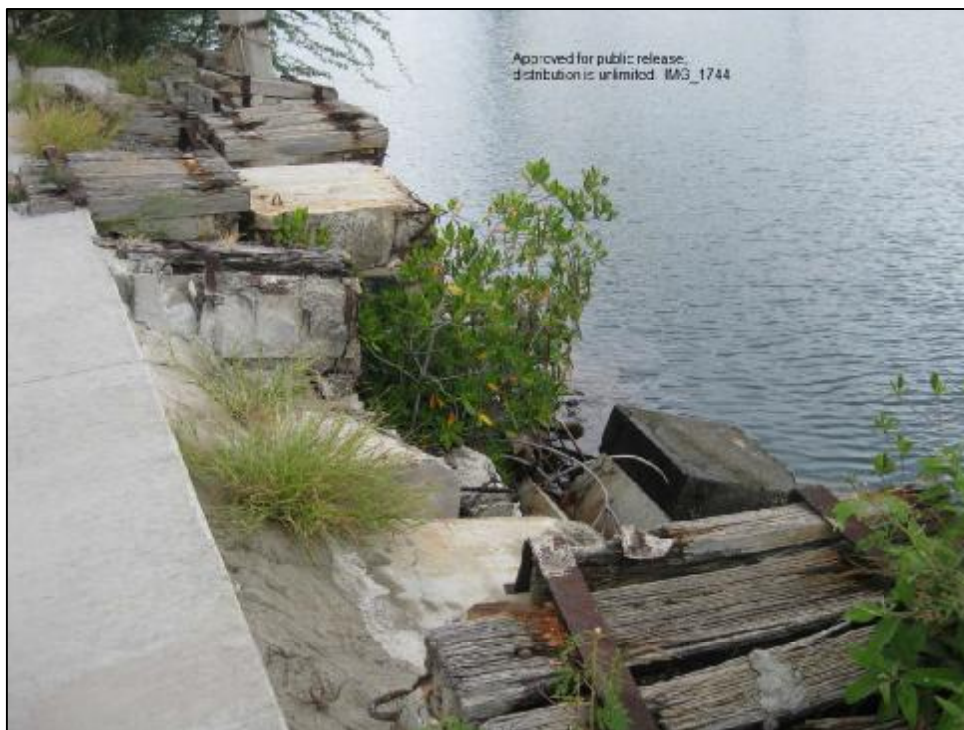
Photograph No. 3: Small shrubs observed growing in concrete. However, this did not appear to impact the erosion controls.

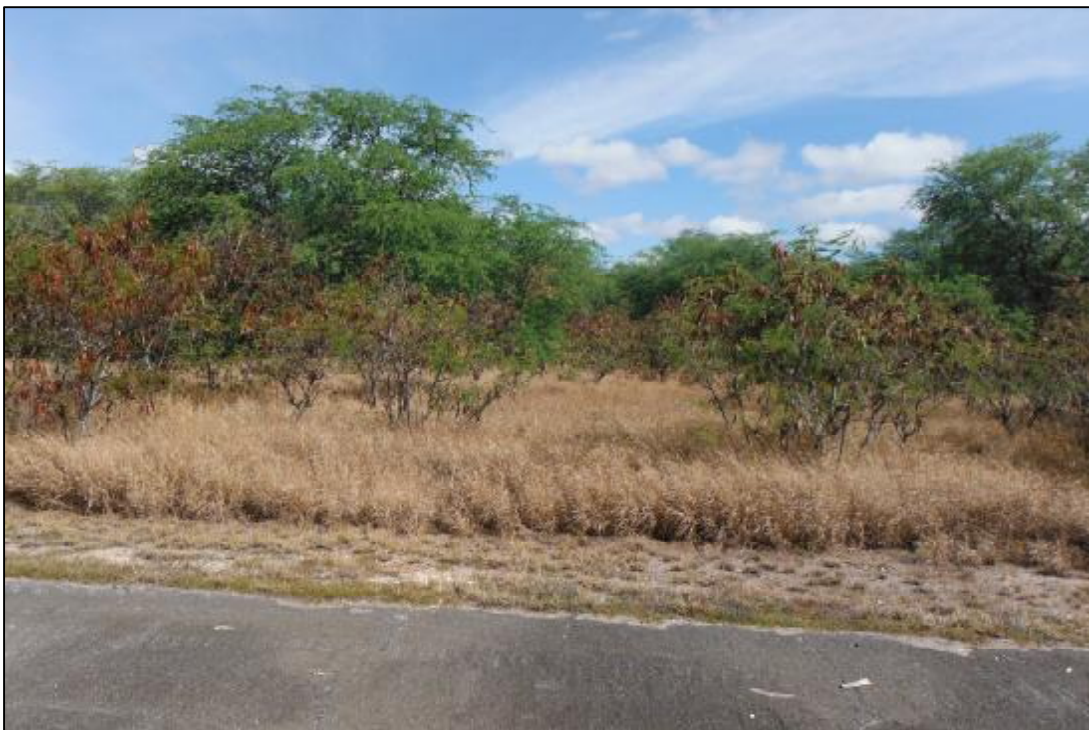
Photograph No. 2: Dry grass, haole koa, and Kiawe trees growing in LUC area.

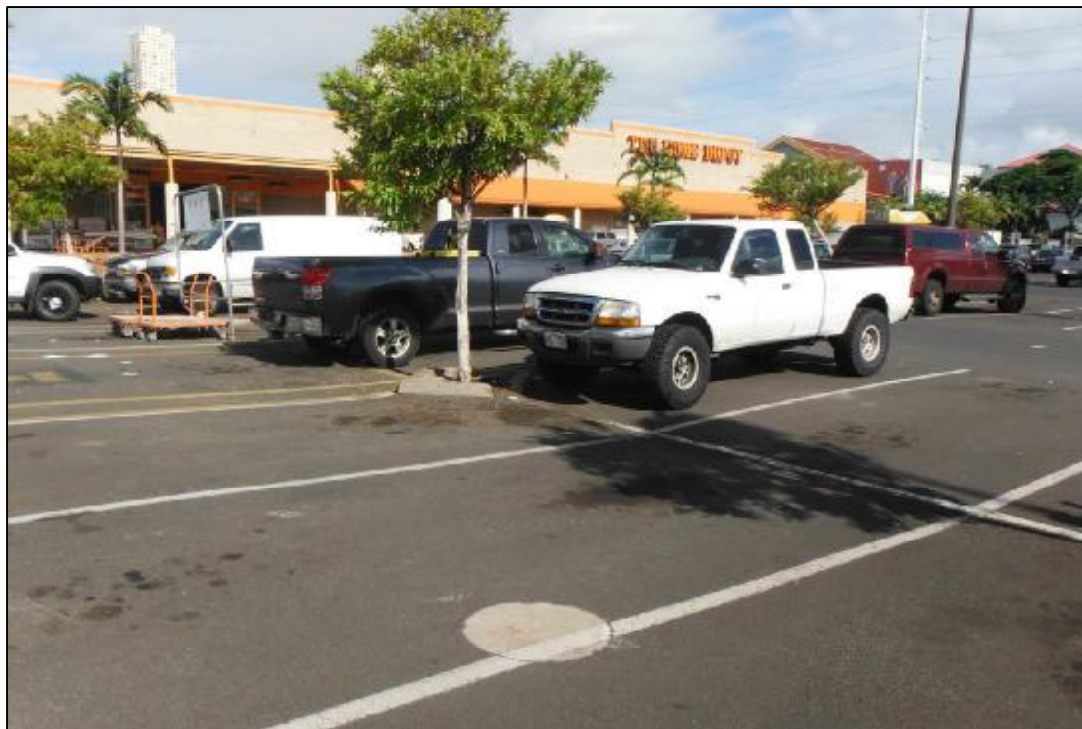
Photograph No. 3: Abandoned monitoring well MW-07 within Home Depot parking area.

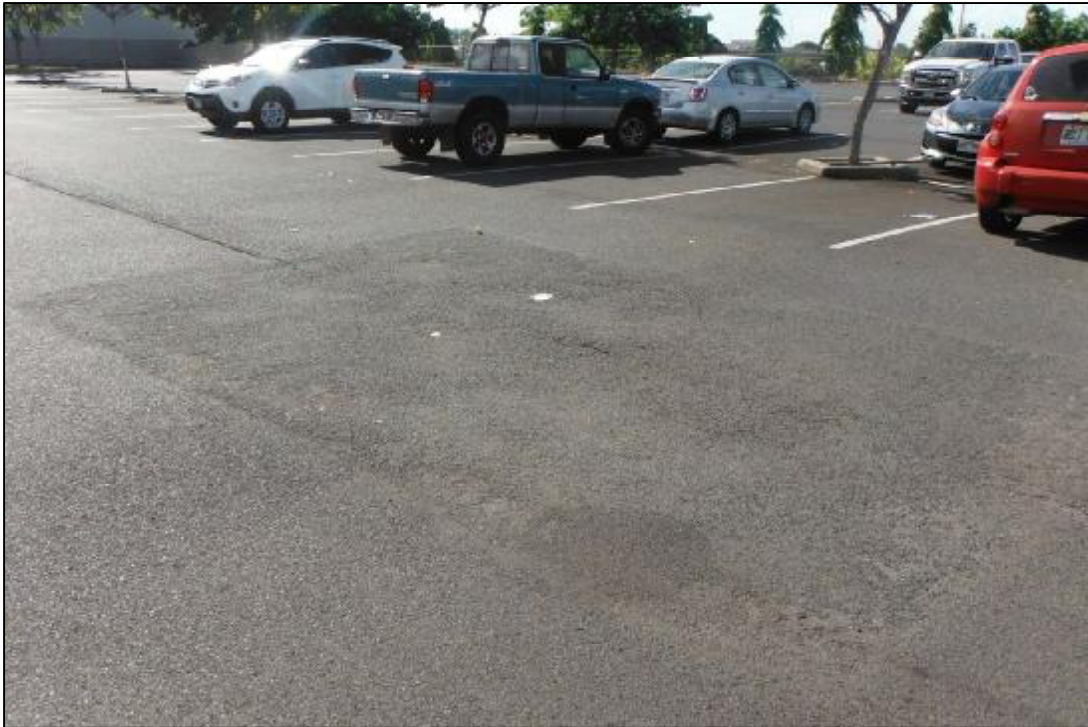
Photograph No. 5: Variation in asphalt pavement in Public Storage parking area.

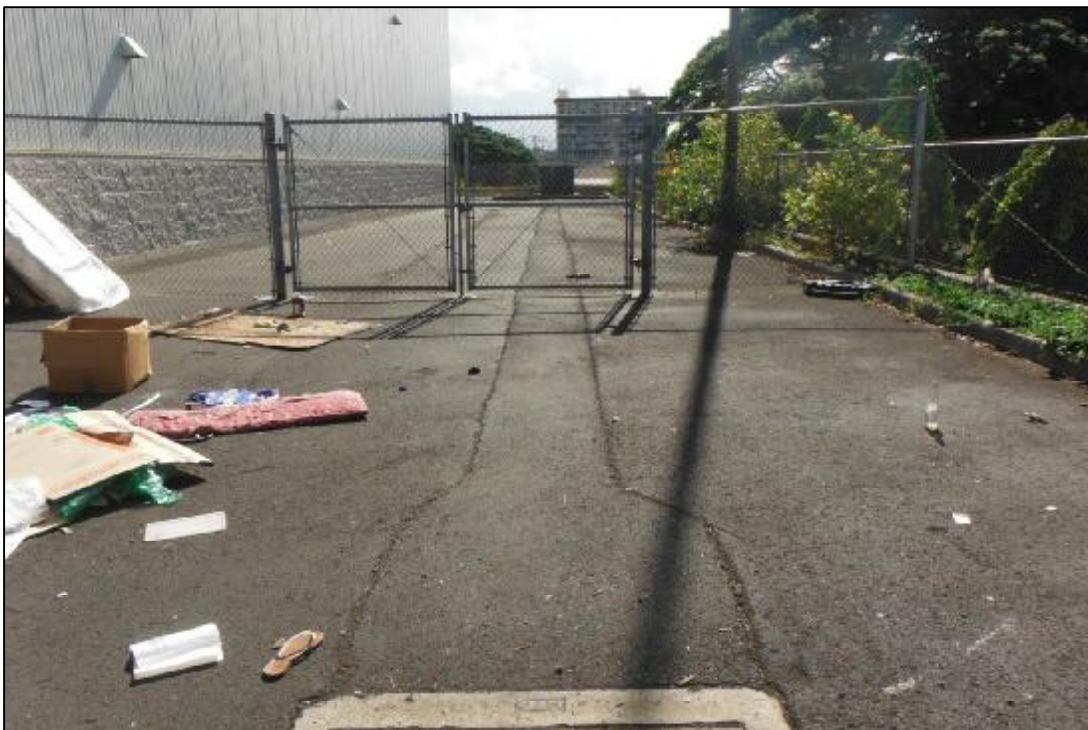
Photograph No. 6: Pavement variation on south side of Public Storage building.

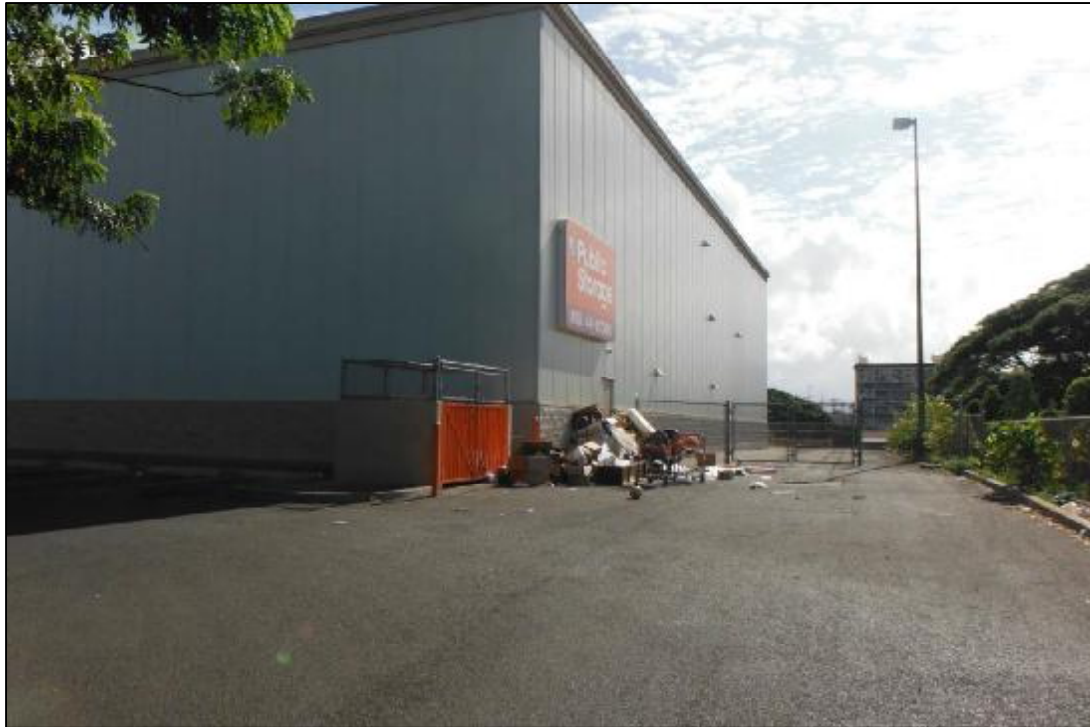
Photograph No. 5: Unauthorized dumping on southwest corner of Public Storage building.

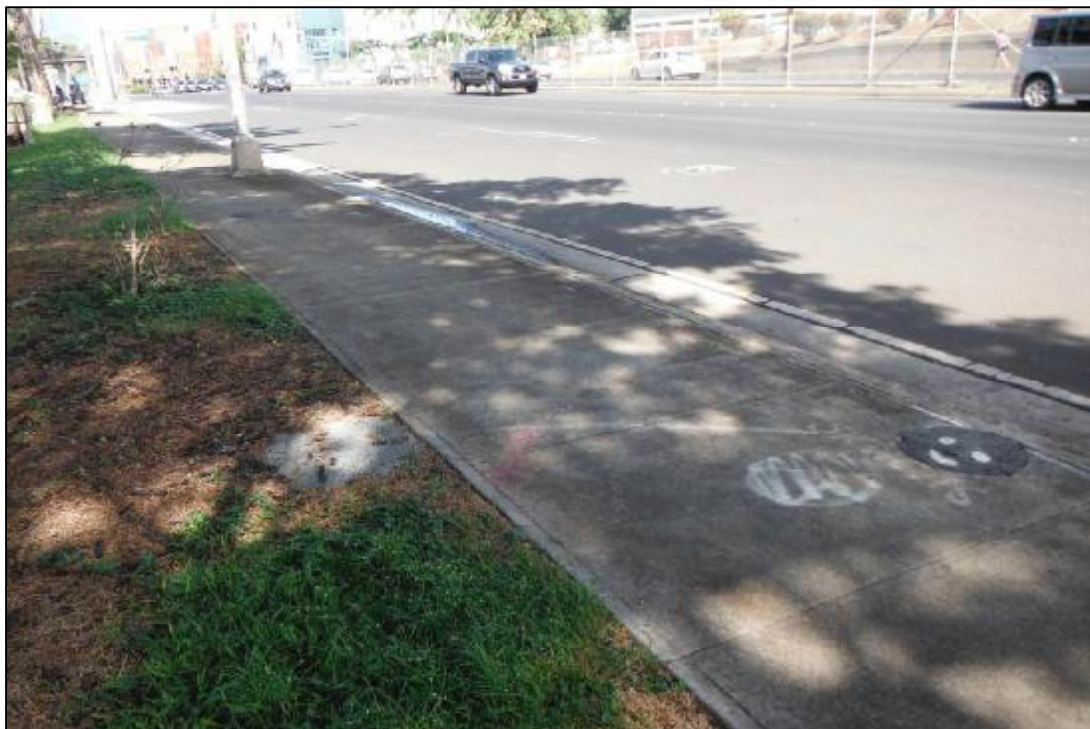
Photograph No. 6: Asphalt and gravel patch observed adjacent to northern border of LUC area.
